# Alpha Home & Commercial Building Inspections

## Property Inspection Report

Sample 37 Year old residential beach front, Rye, NH 03870  
Inspection prepared for: Sample Client  
Real Estate Agent: Lorrie Gould - Lorrie Gould Real Estate Broker

Date of Inspection: 10/15/2015 Time: 1:15 PM  
Age of Home: 37 years Size: 1438 sf  
Order ID: 2989

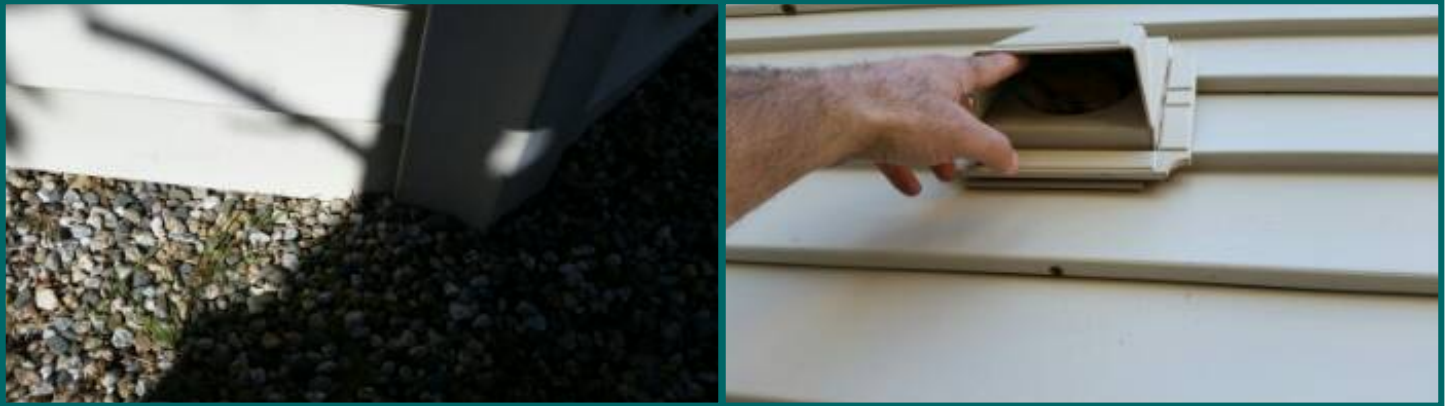
vent on left side of house is blocked with insulation

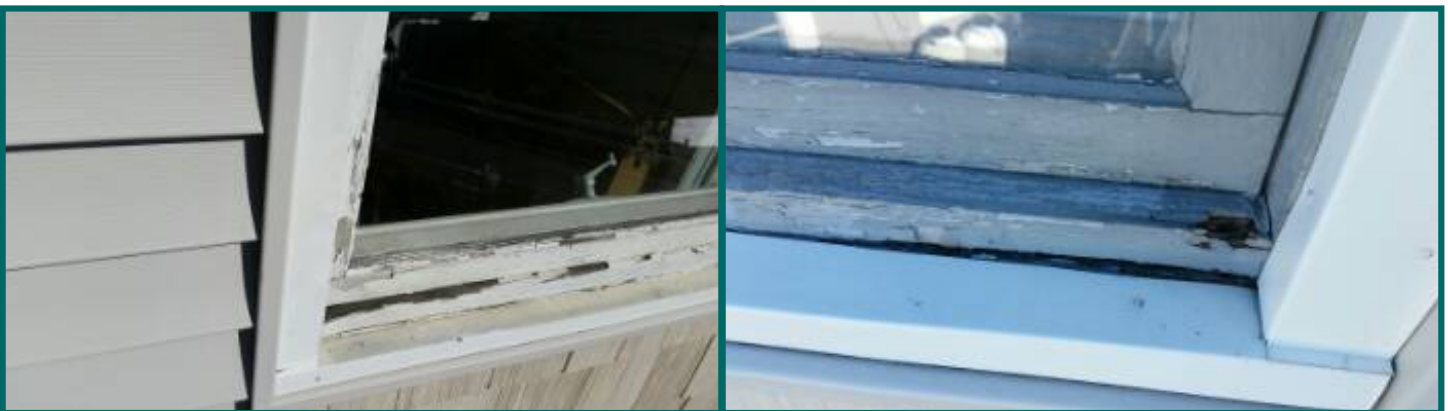
3.1. Deterioration of frames at one or more window, some peeling paint and gaps on exterior wall window frames. Recommend full assessment of windows and repairs by a qualified contractor as needed.

3.2. Peeling paint observed at one or more window and or window frame, suggest scraping and painting as necessary.

peeling paint at upper exterior window

deterioration to frame at upper window

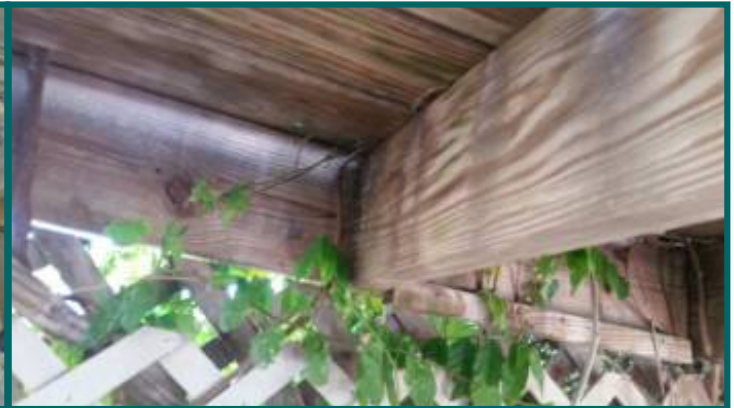
6.3. One or more support joists are missing properly installed mechanical hangers, recommend installation and proper nailing of joist hangers by a qualified contractor.

missing joist hangers at outside rim frame

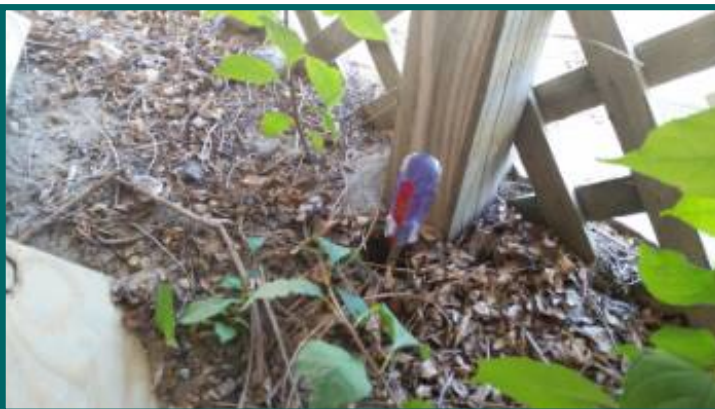
6.4. One deck support post is not in contact with footing, is loose, recommend assessment by a qualified contractor.

center post has no contact with ground or footing

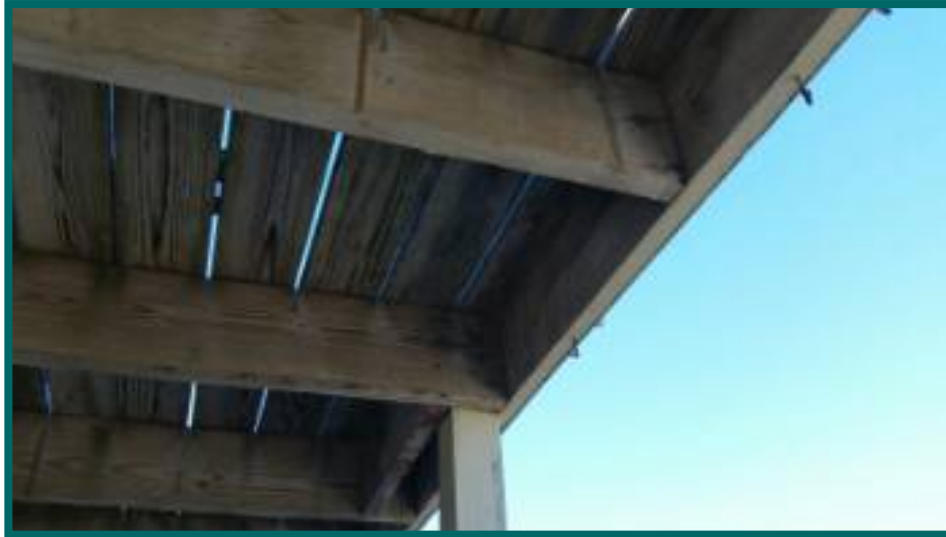
Missing Joist hangers.

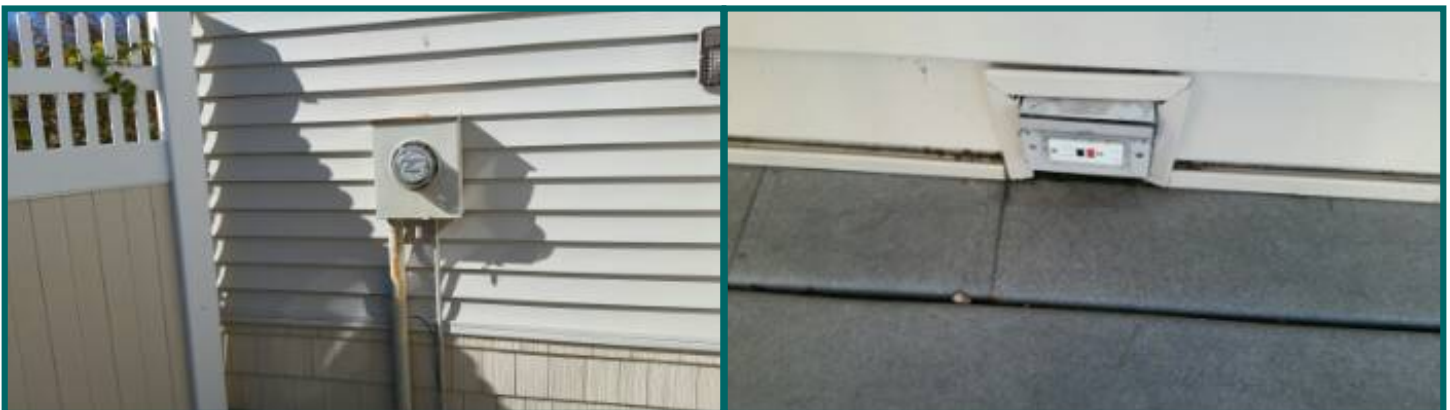
7.3. One or more exterior wall outlets have no power, recommend repairs by a qualified electrician.

7.4. One or more exterior outlet has damaged or missing weatherproof cover, recommend repairs by a licensed electrician.

no power missing weatherproof cover at lower sliding door area

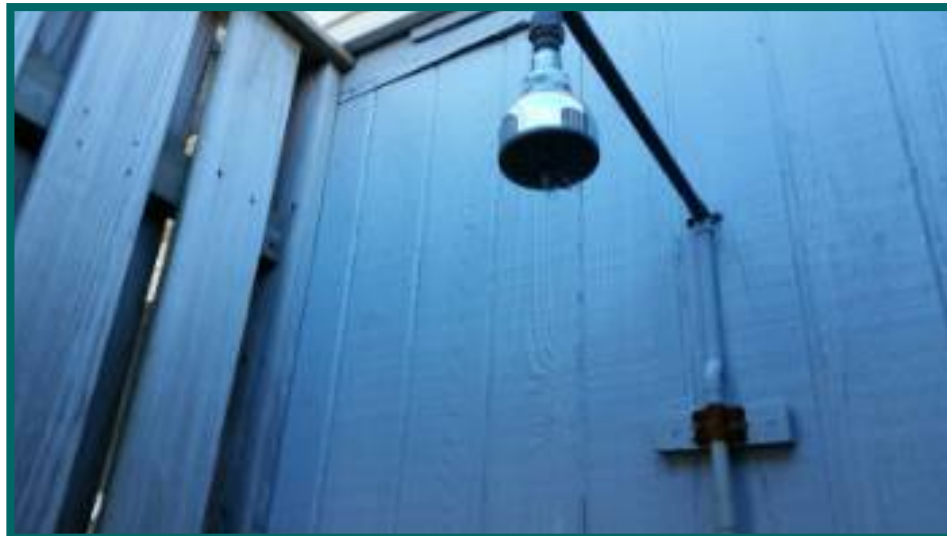
8.1. low water pressure to outdoor shower area recommend checking with homeowner and or assessment by licensed plumber

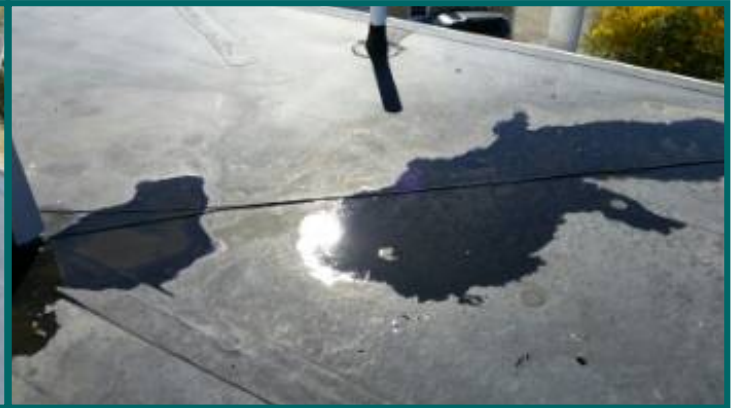
1.3. Water ponding in areas, roof is draining improperly, this can contribute to roof leaks and damage, recommend assessment by a qualified roofing contractor.

ponding on second upper room

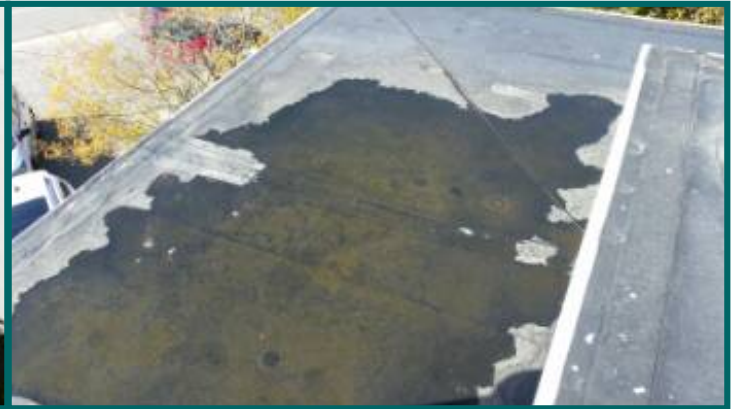
ponding at lower roof

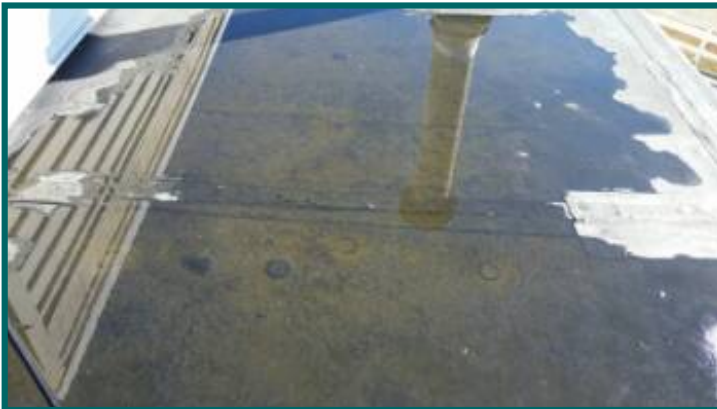
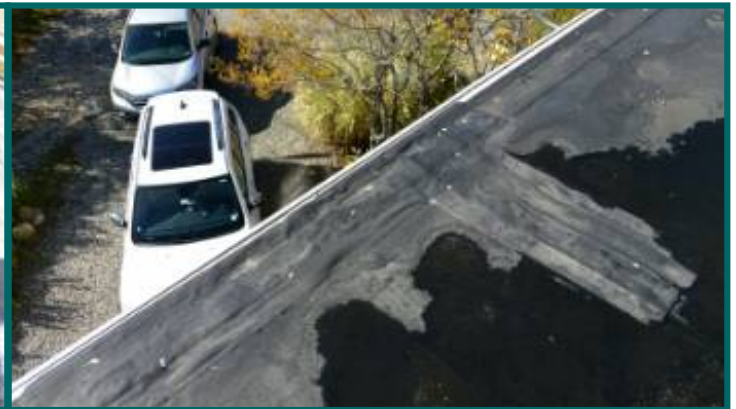
A few areas of patches on roof surfaces should be inspected and resealed from time to time

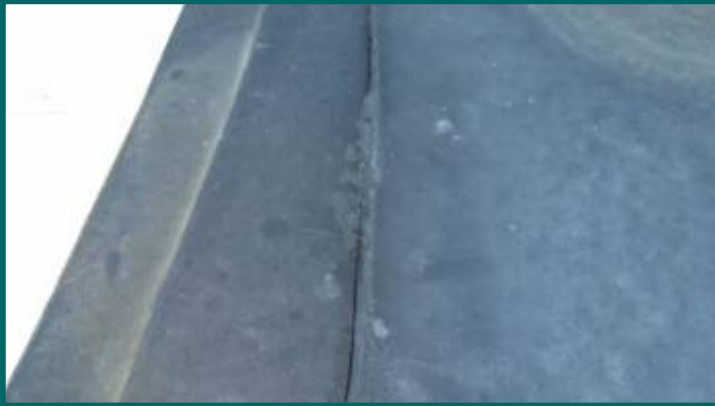
1.2. One or more areas of shingles lifting or loose, shingles should lay flat to help prevent water intrusion, recommend assessment and repairs by a qualified roofing contractor.

lifting seam

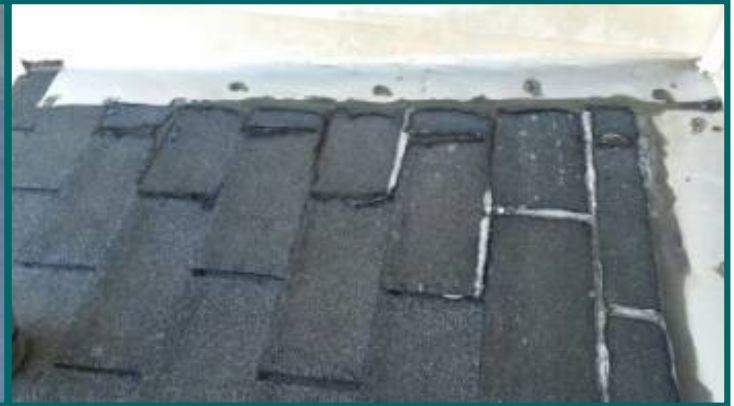
damage and prior repair to shingles over rear shed

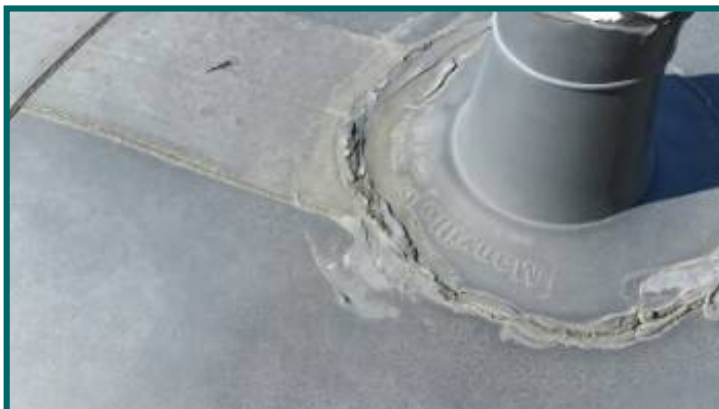
2.2. Sealant around chimney and **vent stack** penetration is dried and cracking. Recommend inspection and proper repair by a qualified roofing contractor.

crack sealant on second roof vent stack

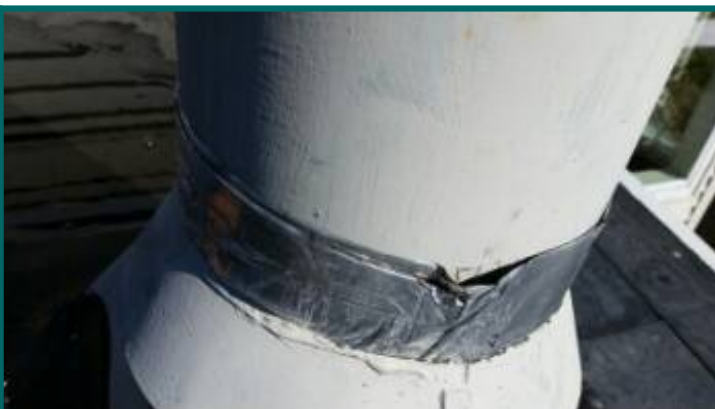
2.1. Metal flashing around chimney is lifting and or damaged , flashing should lay flat to prevent water intrusion, Recommend repair by a qualified roofing contractor.

flashing tape is lifting on fireplace vent stack

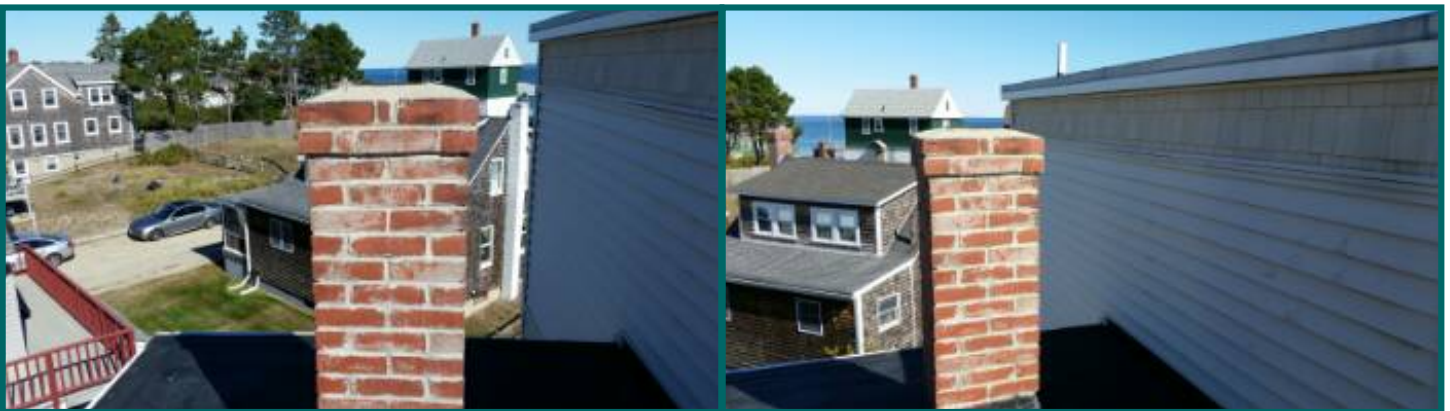
4.3. Chimney clean out is full recommend cleaning.

4.4. Efflorescence observed; often a sign of water infiltration/exfiltration and can be a precursor of masonry deterioration. Recommend monitor condition and assessment by a qualified masonry contractor as needed.

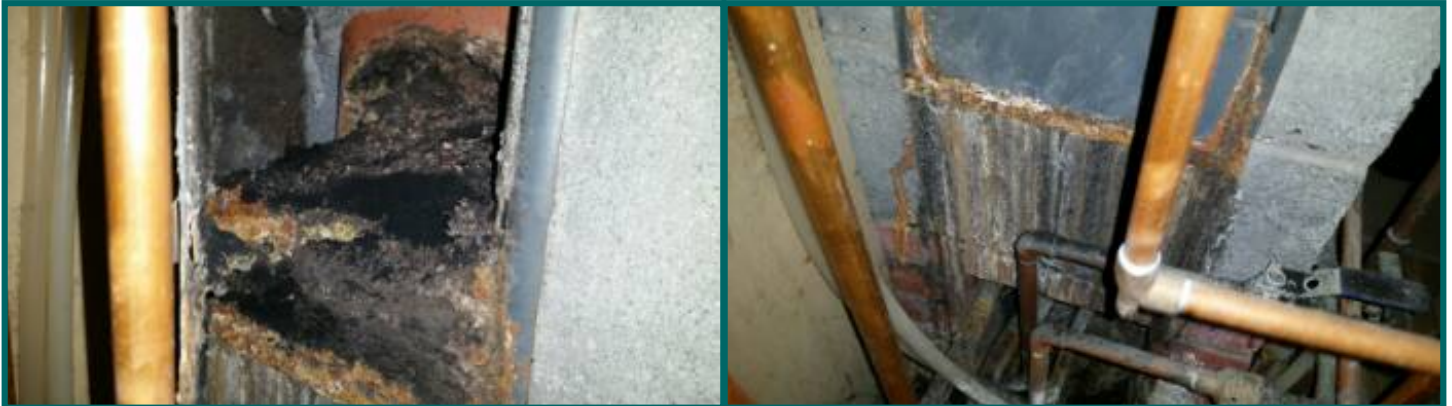
Chimney clean out

Stains at clean out

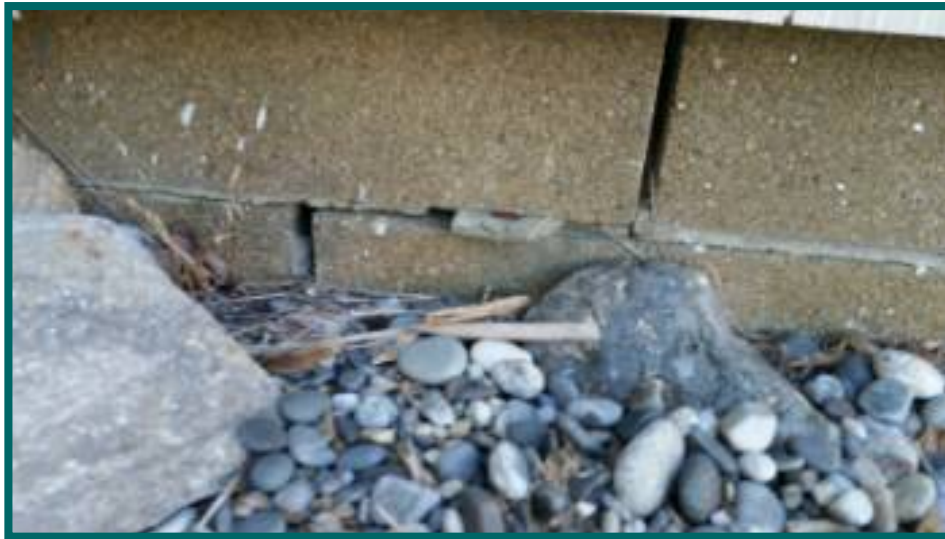
1.4. There is step cracking to foundation walls, this can be typical for age of home. These areas should be monitored closely for further movement and any signs of water intrusion and repaired as needed by a qualified masonry contractor.

damage grout lines on left side of house

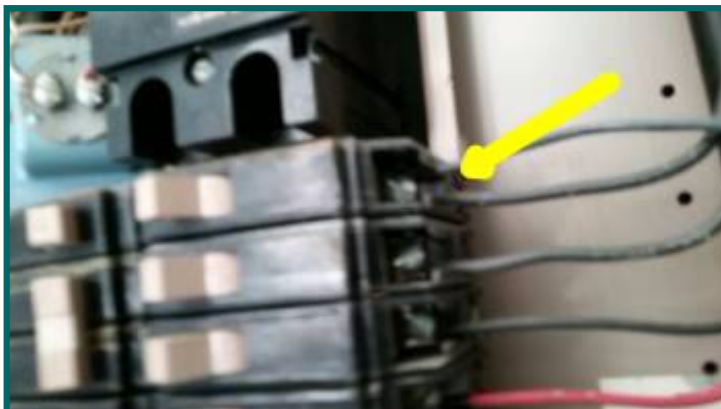
2.3. One or more breakers are double tapped, two or more wires under one breaker screw, this condition can cause loose wire connections or nuisance tripping, recommend repair by a qualified electrician.

double tapped circuit.

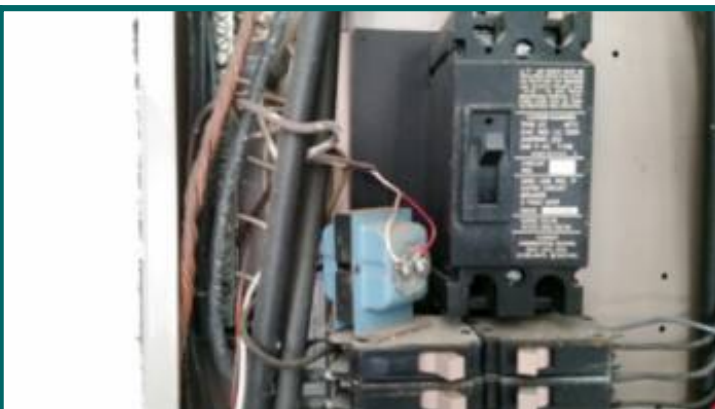
2.4. The doorbell transformer is located inside the main electric panel, this can cause overheating inside the panel. Best practices would locate the transformer outside of the panel.

transformer

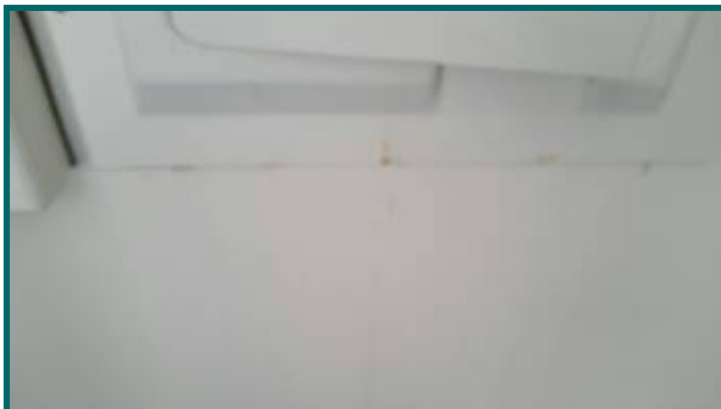
Staining below wall and bottom of panel

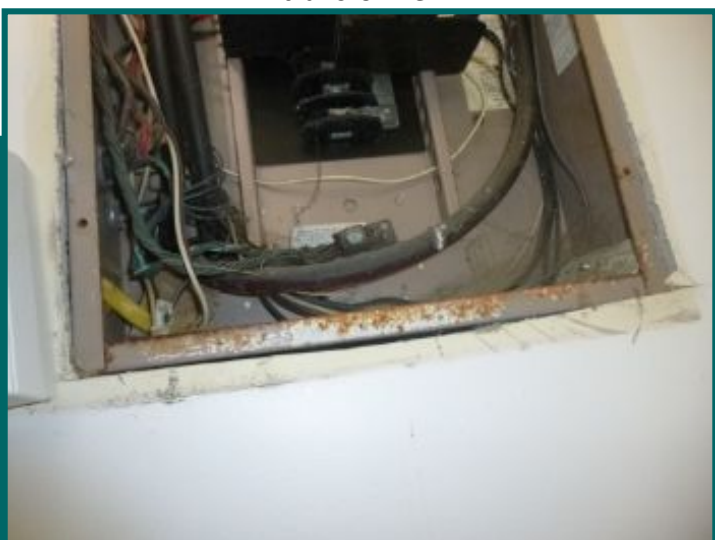
2.2. Corrosion noted inside panel, recommend monitor condition and repairs if needed by a licensed electrician.

Corrosion at bottom of panel.

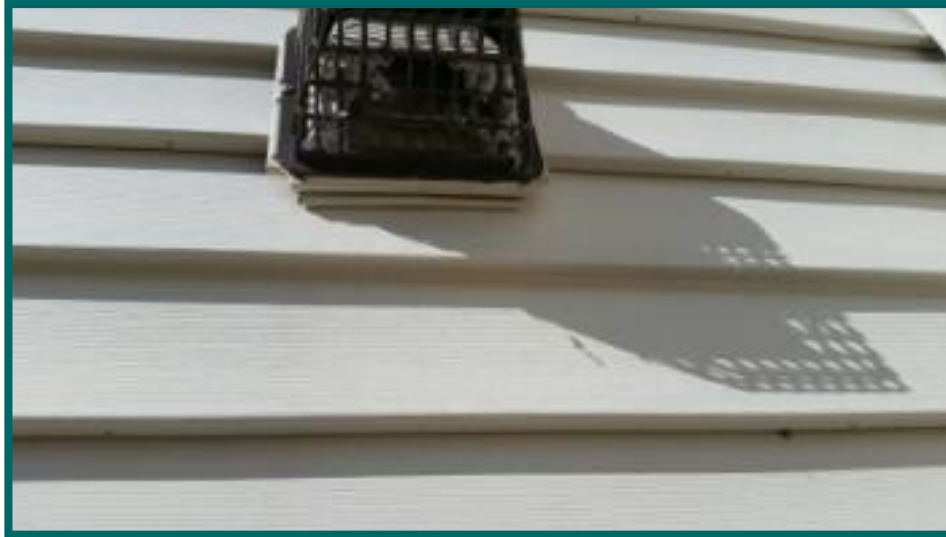
- 4.1. Recommend regular inspection and cleaning of dryer vent to help prevent fire hazard.
- 4.2. There is excessive lint at dryer vent termination, recommend inspection and cleaning as needed.

Dryer vent termination

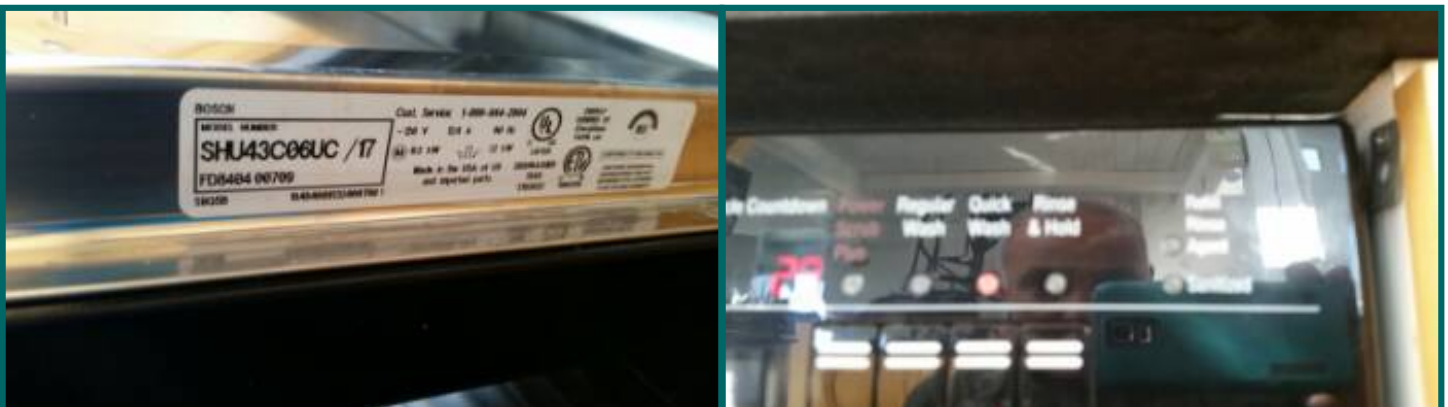
2.4. Unit is not properly fastened, recommend securing to countertop using the appropriate length screw to prevent tip from exiting top of counter causing damage.

Not properly secured

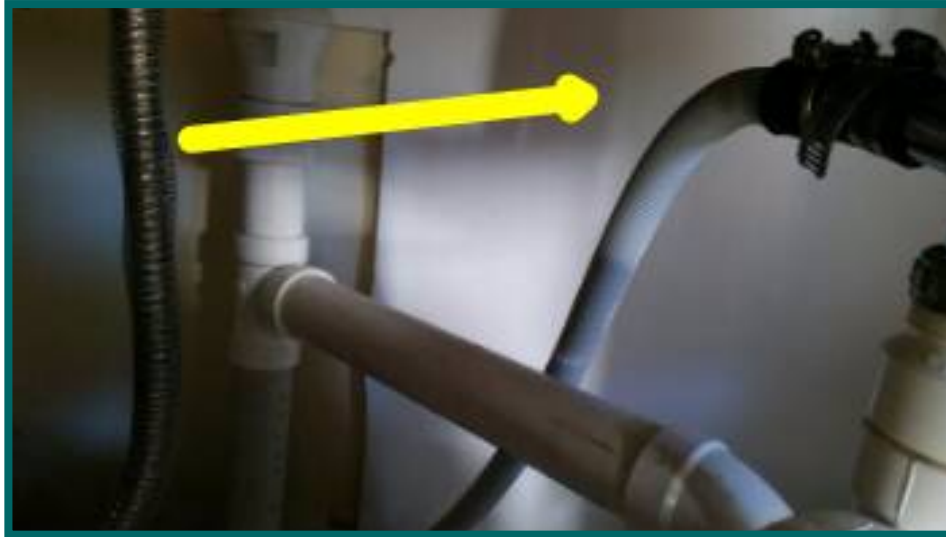
2.3. Dishwasher is missing high loop on drain, this is needed to prevent back flow from sink to dishwasher, recommend repair by a qualified tradesman.

No high loop in drain line.

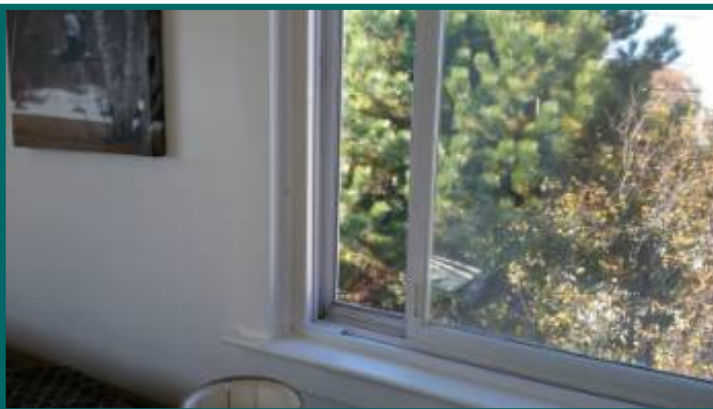
2.3. One or more windows have tight sash, window is difficult to open. Recommend repair by a qualified window contractor.

windows are difficult to slide

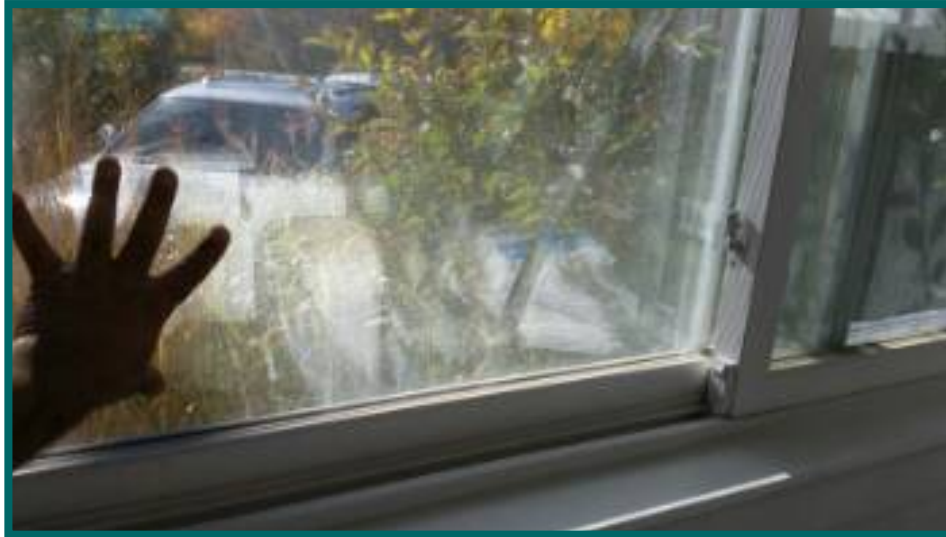
2.2. One or more windows have broken seals (fogged) this condition can diminish the energy efficiency of the window and cause permanent hazing to the glass, recommend further assessment of windows and repairs by a qualified window contractor as needed.

fogged window in basement bedroom

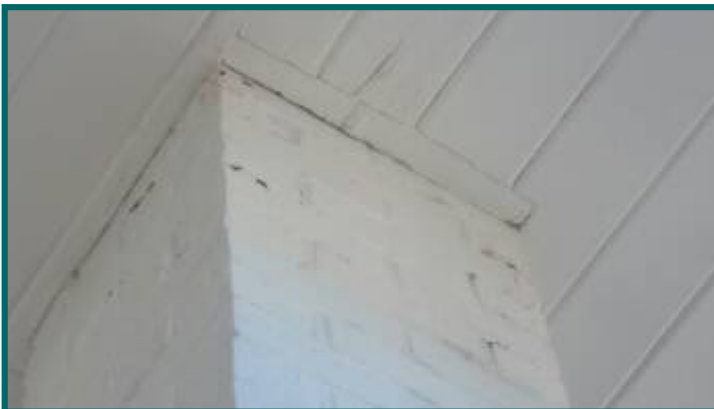
4.2. Stains noted on ceilings in one or more area of home. This is evidence of past or present leaks. They tested dry at the time of the inspection. Recommend repairs of any affected areas and monitor for further water staining.

Ceiling stains at chimney roof penetration.

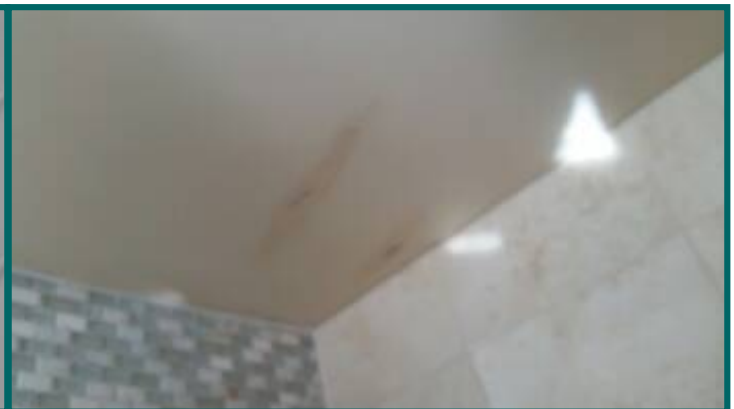
staining above shower

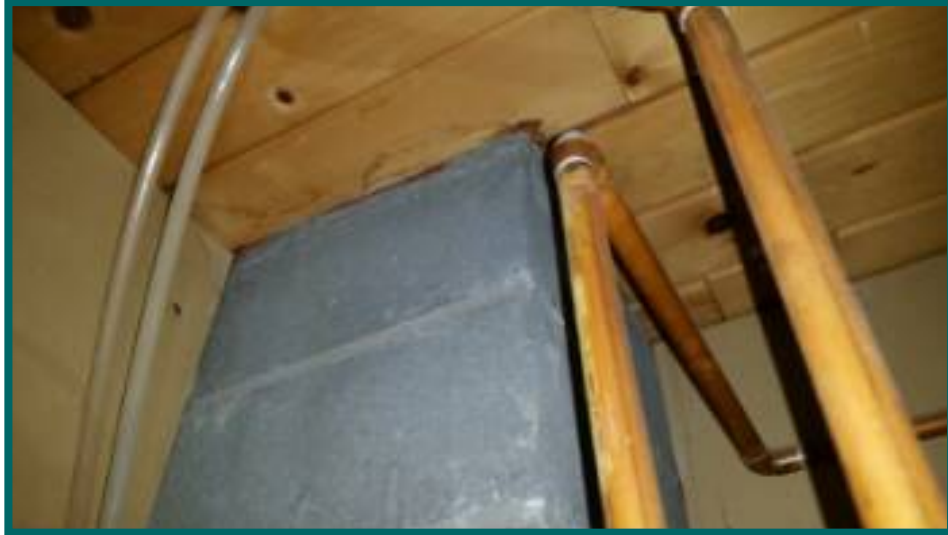
Basement ceiling around chimney

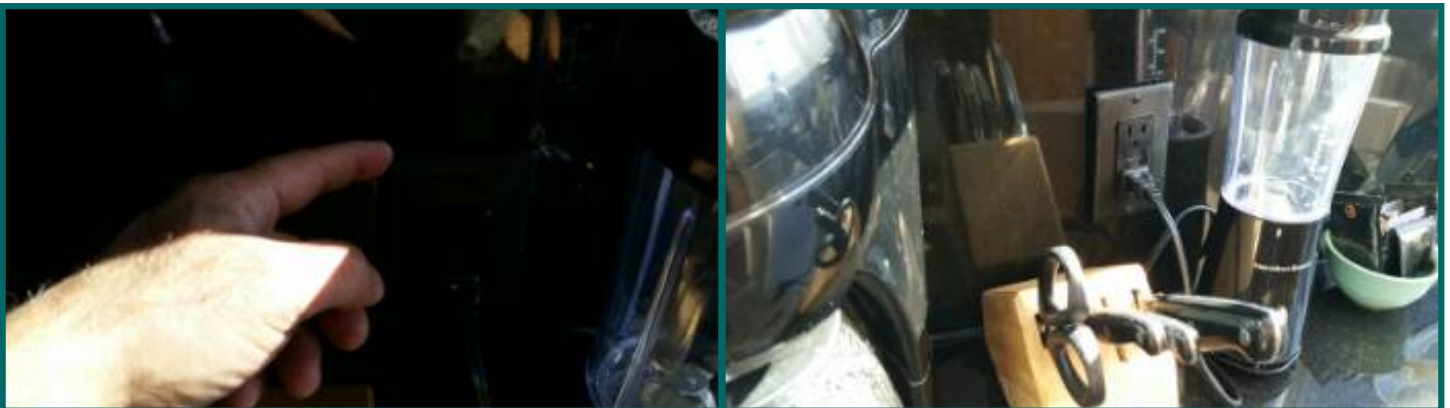
6.2. One or more wall outlet is loose, recommend repair by a licensed electrician.

kitchen counter outlet is loose

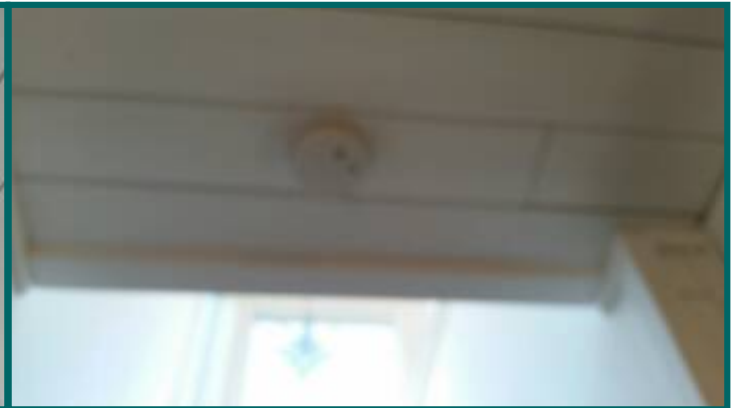
7.2. Smoke and or CO detectors are missing at one or more bedrooms, recommend assessment and installation of smoke / CO detectors at the correct locations by a licensed electrician.

There is one smoke detector in bedroom hallway area, no smoke or CO detectors in bedrooms.

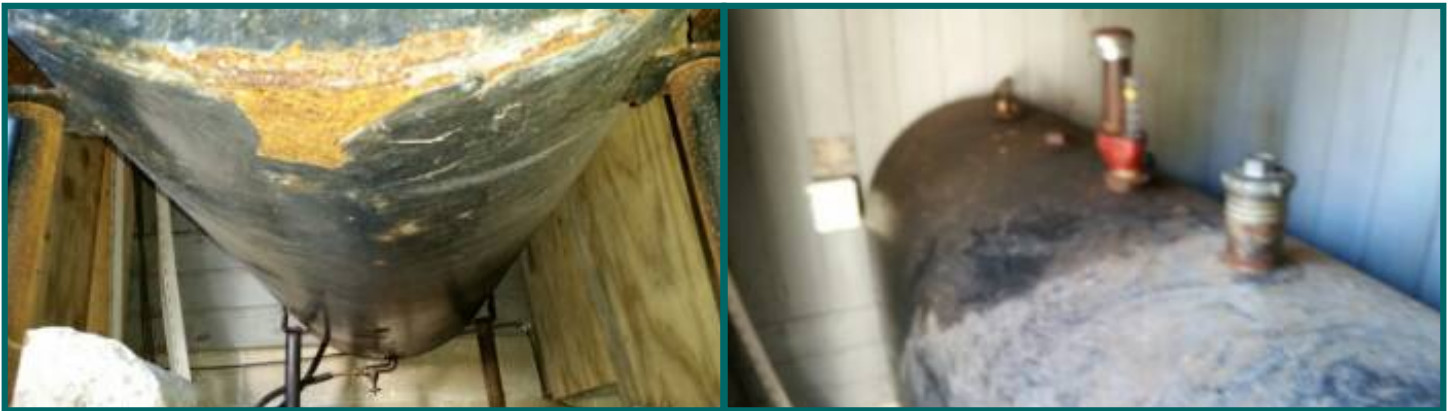
3.3. Corrosion or staining on oil tank, recommend have inspected by a qualified oil burner company. A leaking oil tank can create environmental hazardous conditions. Oil tank should be inspected for evidence of leaking by a qualified oil burner company and replaced as needed.

Underside of oil tank

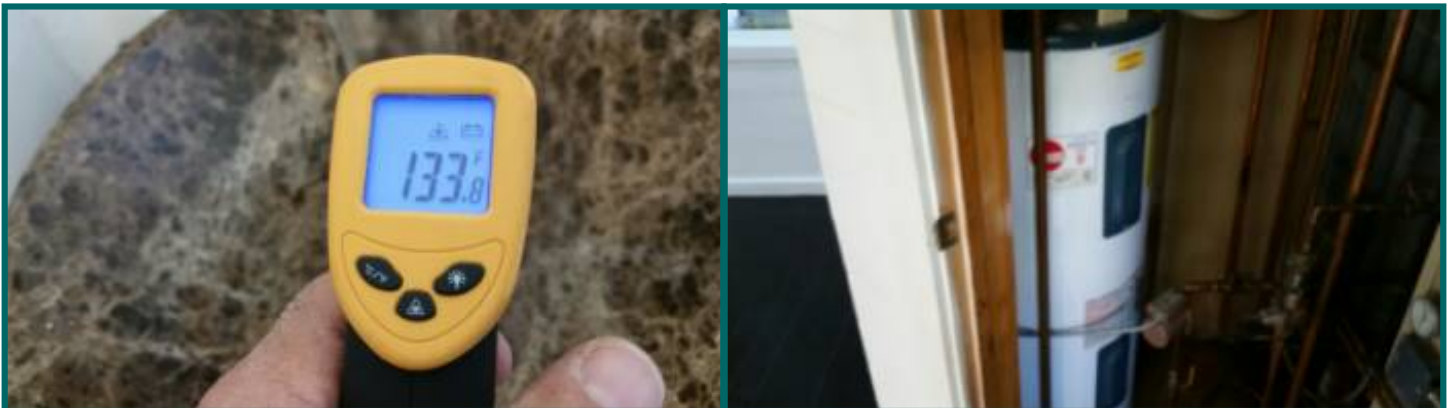
1.3. Water temperature is above 120 degrees, should be set minimum 110 degrees for comfort and maximum 120 degrees to prevent scalding particularly for very young and very old persons.

Water Temperature
