PROPERTY INSPECTION REPORT

Steve Mangekian License # 0054
Alpha Home & Commercial Building Inspections

Date of Inspection: 7/20/2020

The subject property is an office condominium approximately 1,150 sq ft, reported to be constructed in 1984.

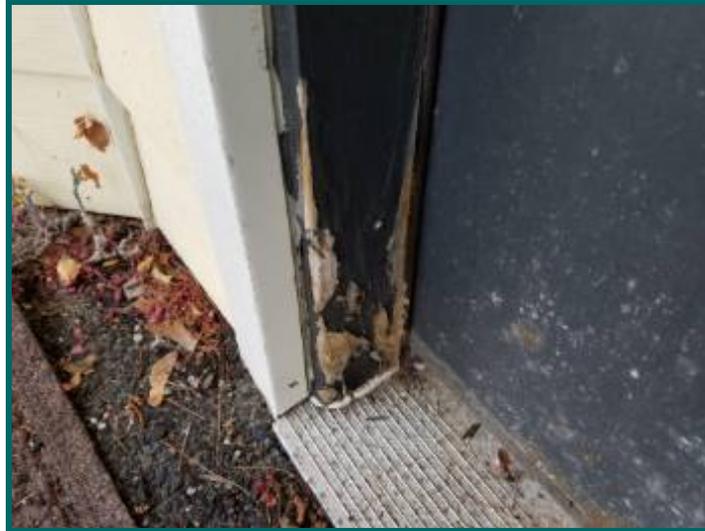
1.2. There is peeling paint at one or more door and framing, recommend scraping, caulking and painting by a qualified contractor as needed.

Peeling paint at front entry

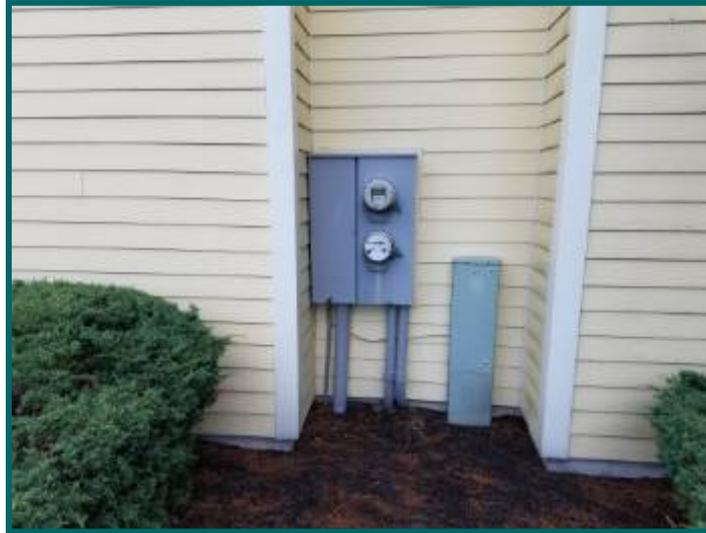
3.1. Main service entrance cable is under ground.

Main service cable entrance

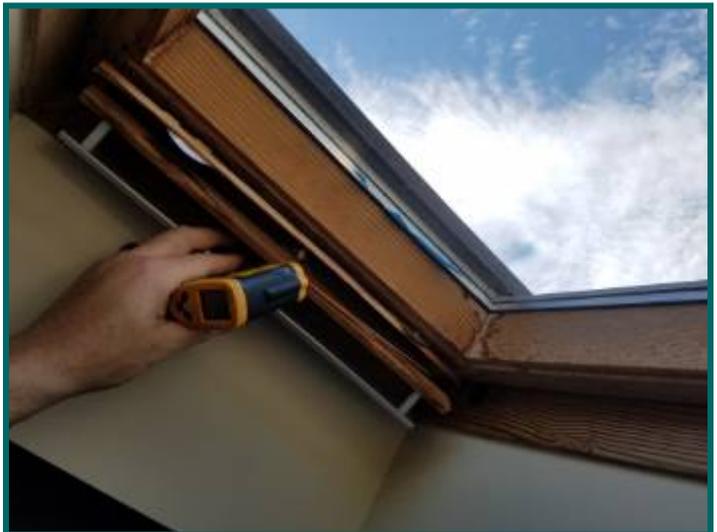
1.3. Sky lights have damage to interior trim, recommend repair or replacement as needed by a qualified contractor.

Damaged skylight trim at front

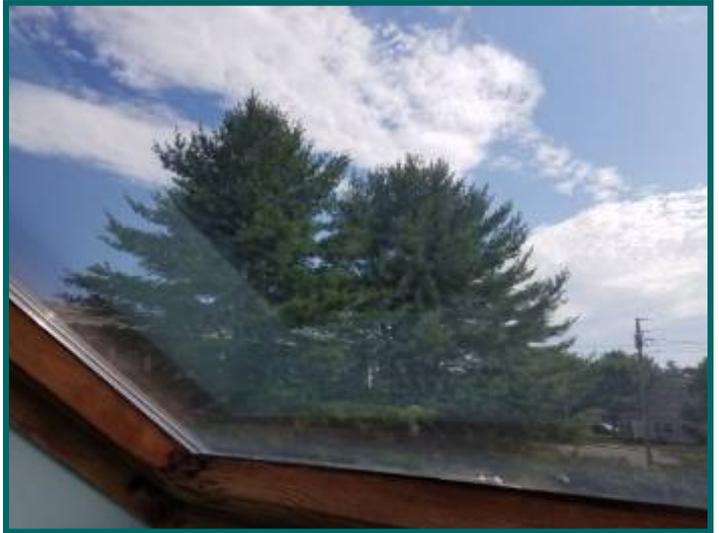
1.2. One or more skylights are fogged, speckle or streaking stains on glass. This is an indication of a broken seal in double panes of glass Recommend assessment of skylights and repairs by a qualified contractor as needed.

Fogged glass at rear

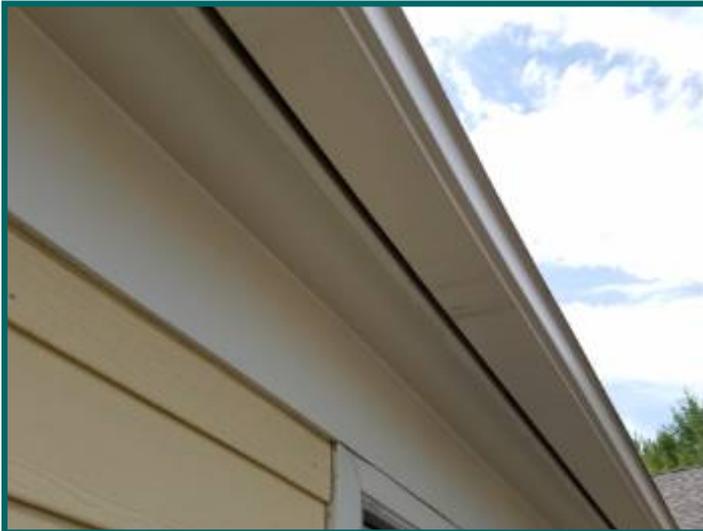
2.3. Gable and / or ridge vents present with no lower soffit vents. Inadequate ventilation can contribute to diminished roof life, condensation, higher energy costs, fungal growth and ice damming. Recommend assessment by a qualified attic ventilation contractor.

No lower venting

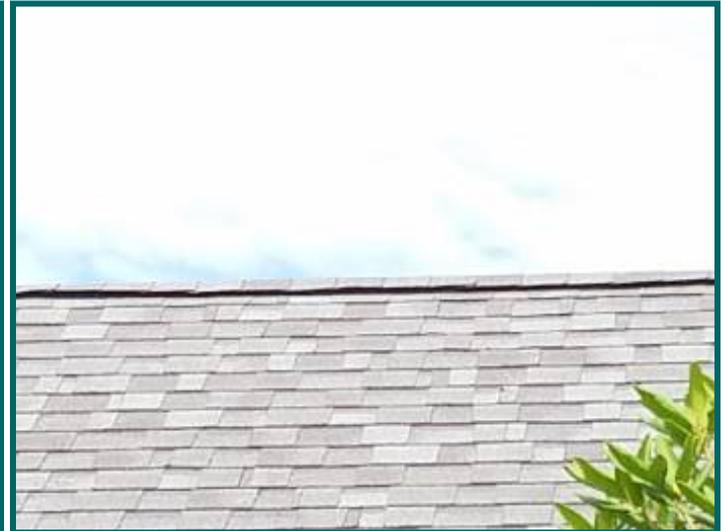
2.1. Ridge exhaust venting noted.

Ridge Vent

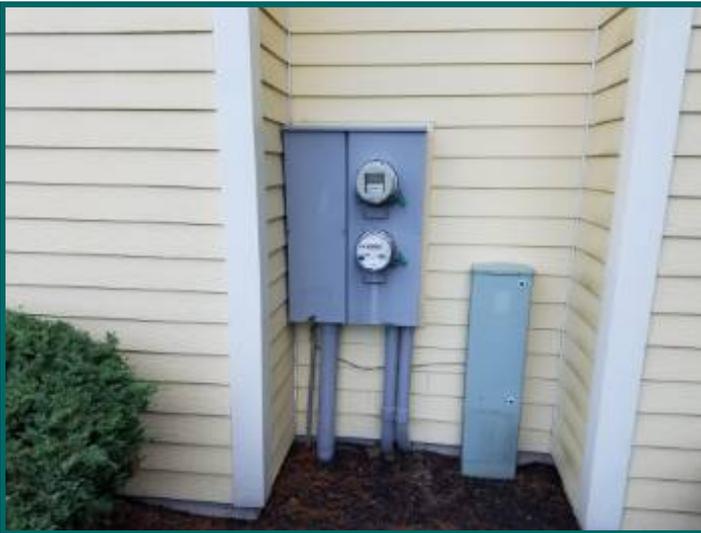
- Circuit breakers are not properly marked at one or more electric panel, recommend marking panels properly for safety.

Common meter bank at front, individual meters and breakers are not labeled

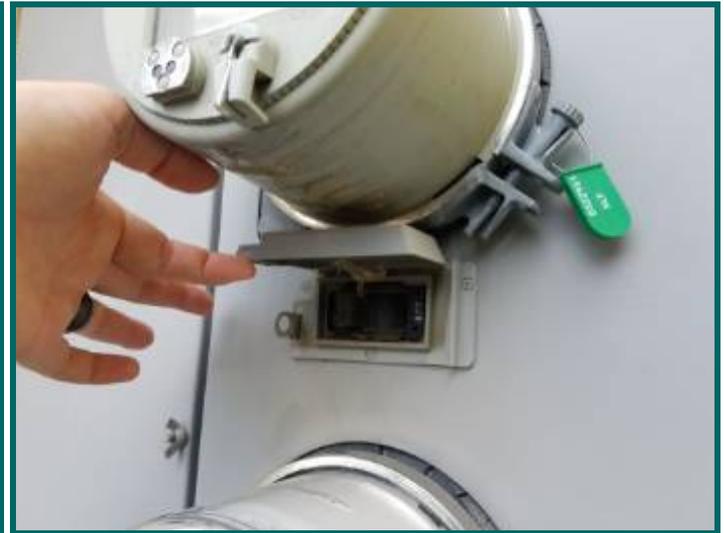
- The service entrance is 200 amp, under ground to an exterior meter bank and panel located at the front entry hall. Disconnecting power requires the deactivation of a single main switch disconnect at the exterior meter which is not clearly marked. One main panel was observed, visible wiring was copper. The electrical service appeared adequate for the current load and use.

200 amp main disconnect at exterior meter

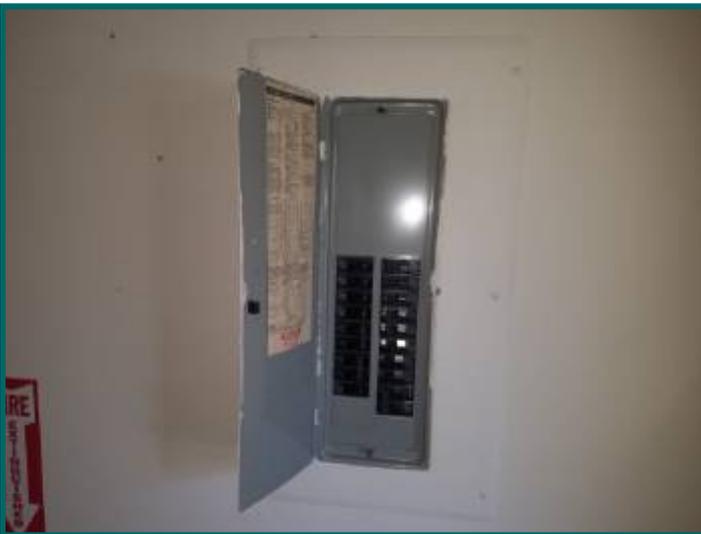
Main panel at entry area

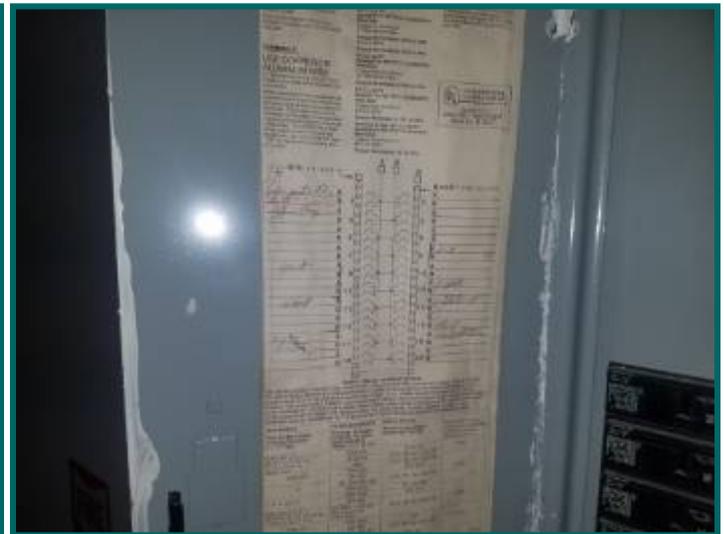
Breakers are not fully labeled

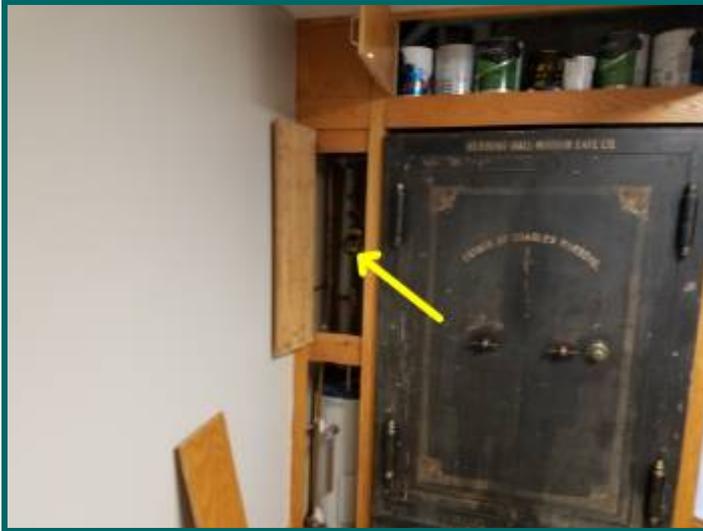
Water meter and shut off valve location

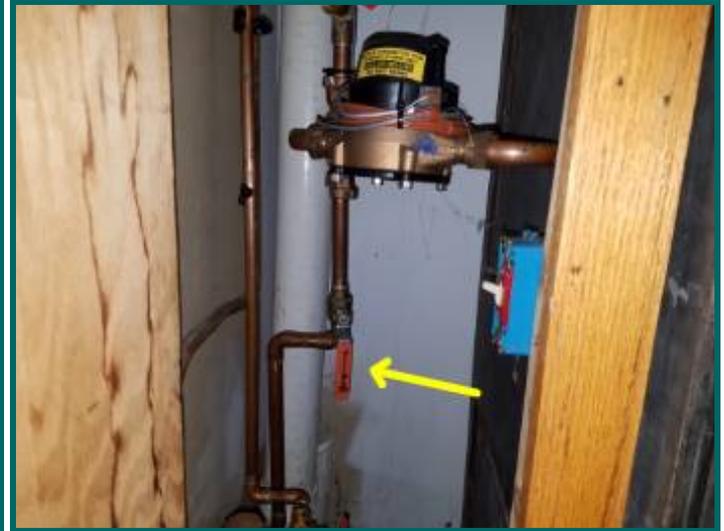
Main water shut off valve is located at water meter

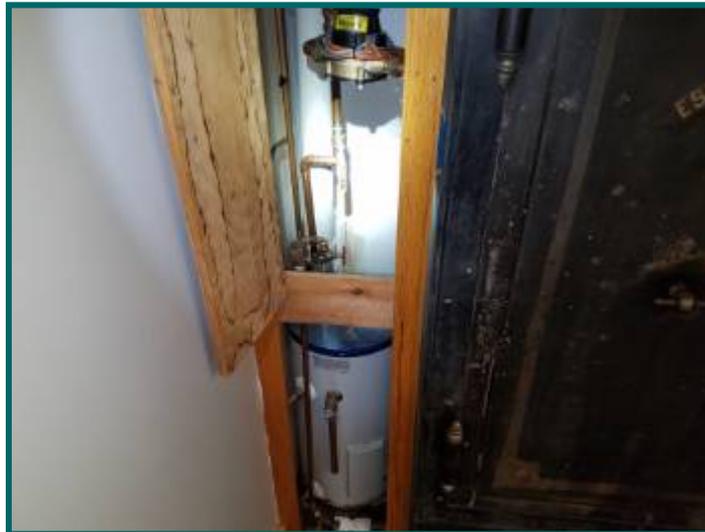
Main drain line termination behind water heater

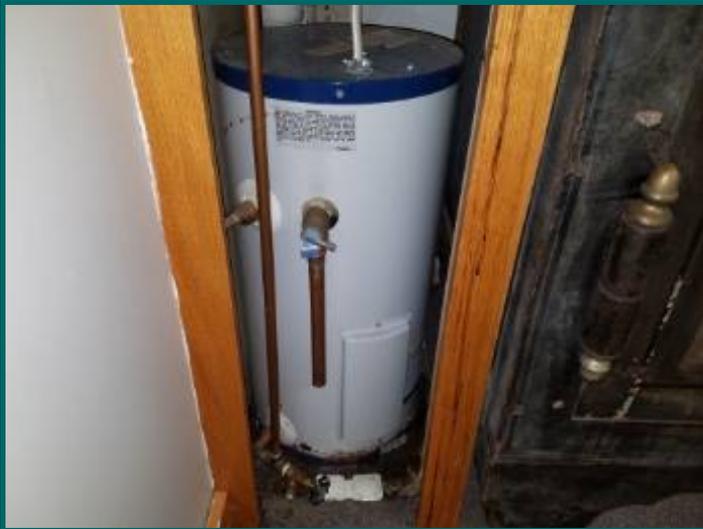
- Building is serviced by a single electric water heater that appears to be original, 35 years old, typical design life for water heater is 10-15 years. Water heater has corrosion on the cabinet and is well beyond its intended design life, recommend monitor for further signs of water and repair by a licensed plumber as needed.
- Water temperature is between 110 and 125 degrees, this is an acceptable temperature. Should be set minimum of 110 degrees for comfort and 125 degrees to prevent scalding hazard, particularly for very young and very old.

Electric water heater below water meter, 35 years old, 12 gallons

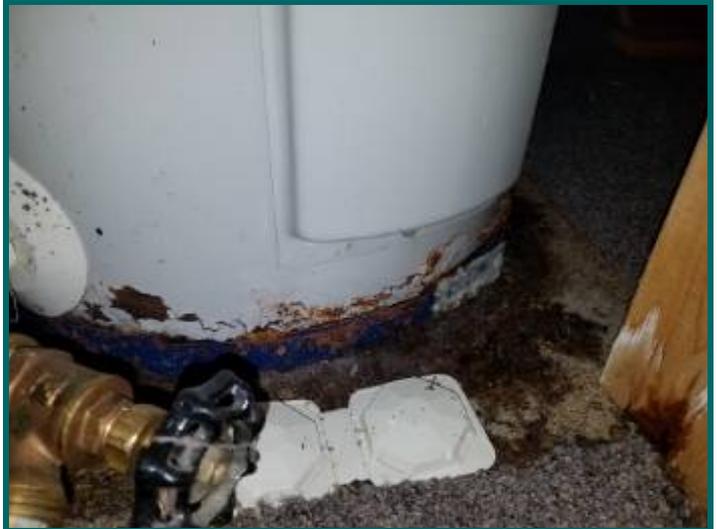
Corrosion on cabinet.

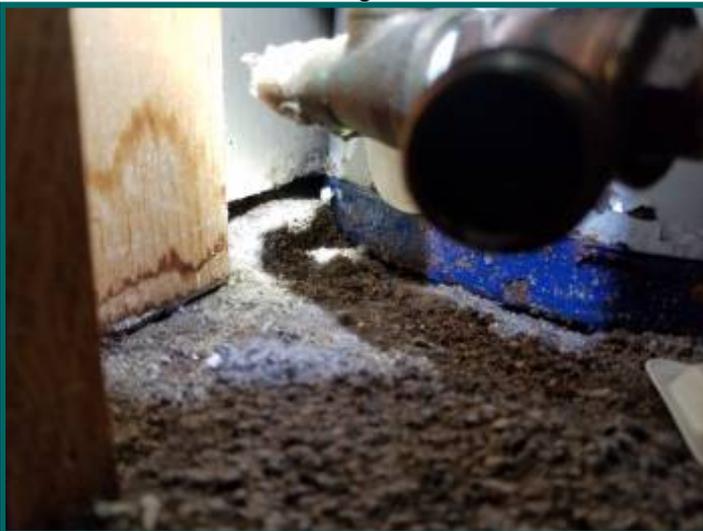
Wet/damp sand around water heater appears to be from condensate

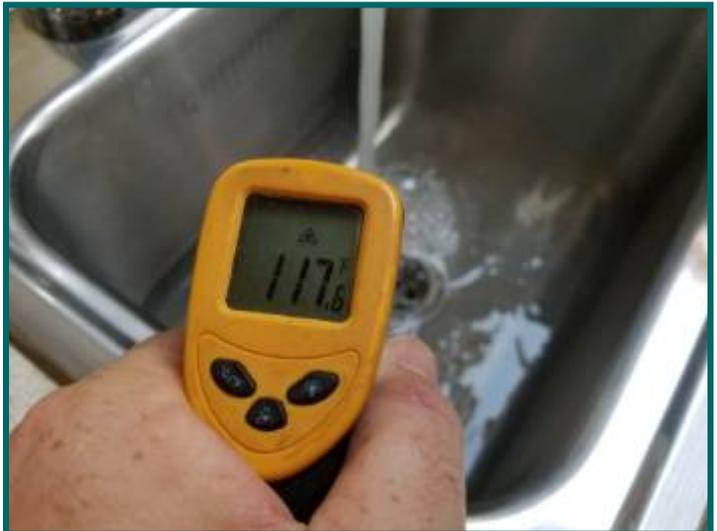
Water temperature

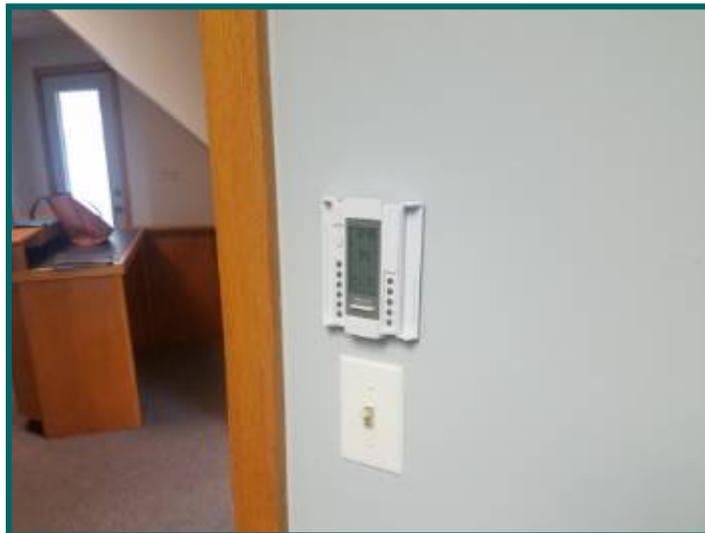
Individual electric heater thermostats

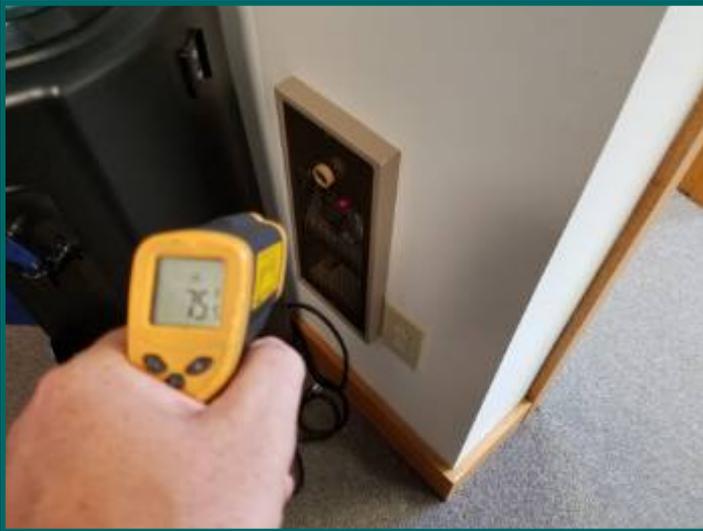
3.2. One or more heat register was not operating, recommend inspection and repair by a qualified HVAC contractor.

Electric wall heater not working at entry desk area

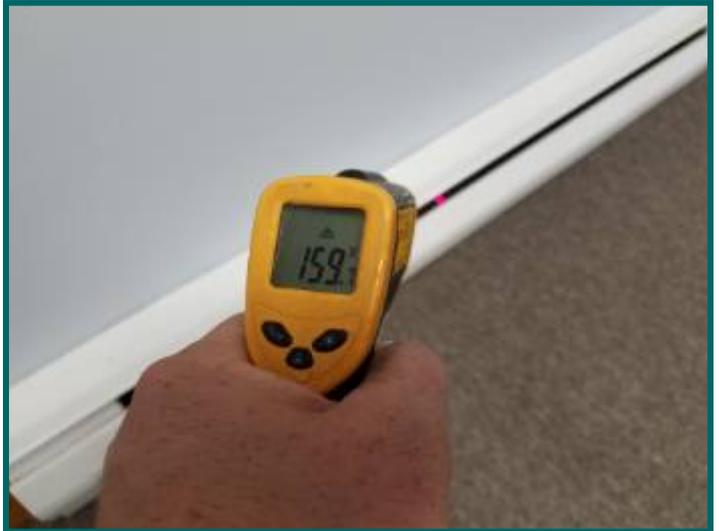
First floor electric baseboard heat working

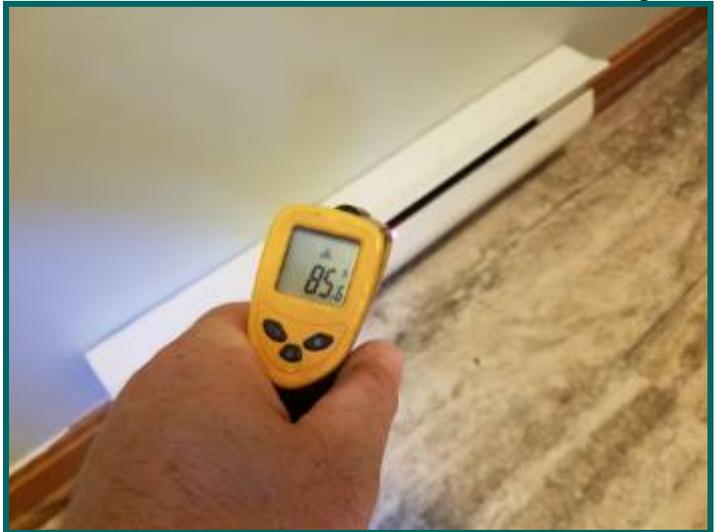
Electric baseboard heater not working at second floor bathroom, may be too hot to test

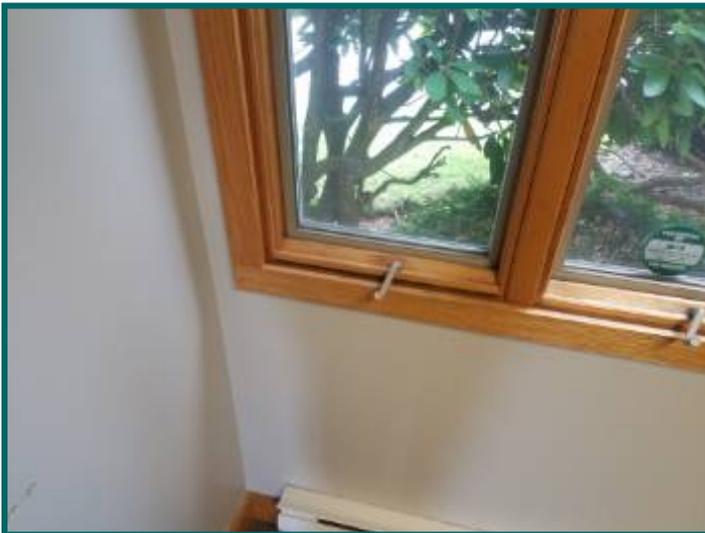
2.2. Casement window crank is broken, will not operate properly at one or more area of the building, recommend assessment of windows and repairs by qualified tradesman.

Damaged window crank at rear right corner office

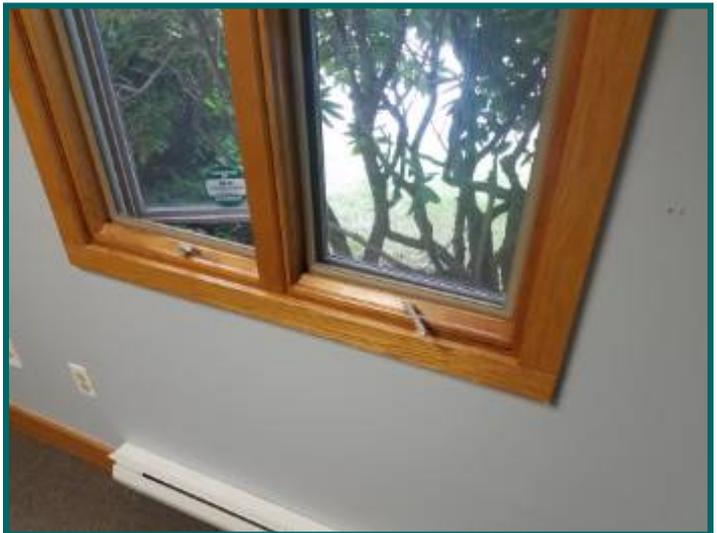
Damaged window crank and heavily corroded crank arm at rear left corner office

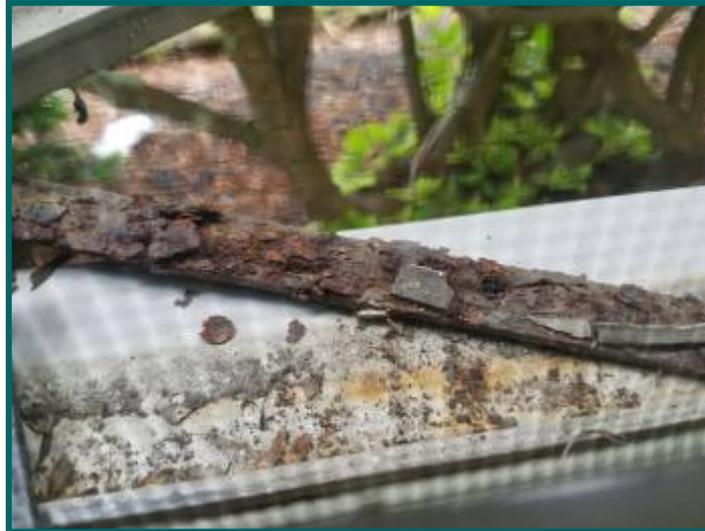
Heavy corrosion on crank arm

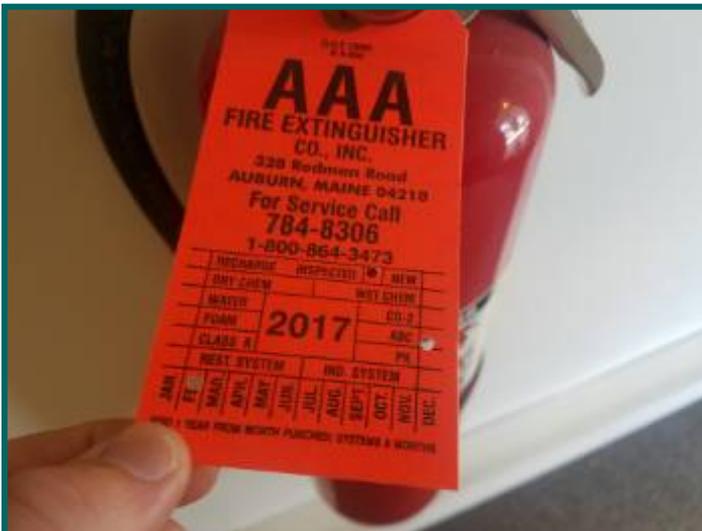
Fire extinguisher tags are expired, dated 2017

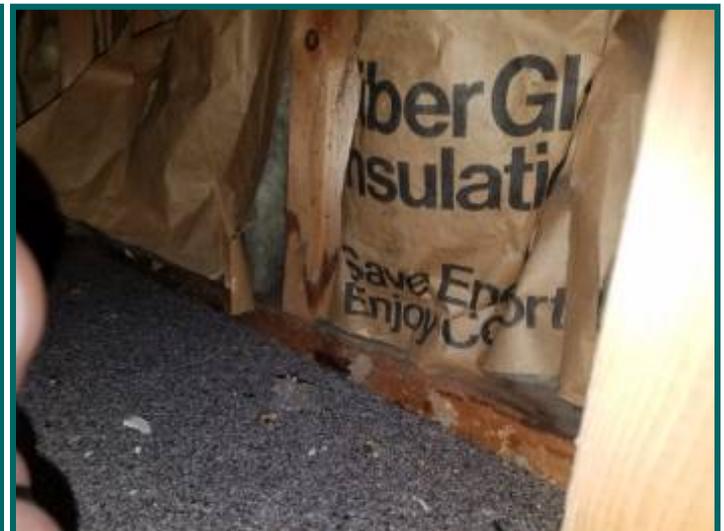
3.2. Stains on walls at one or more area of building, tested dry at time of inspection, recommend checking with current property owner about history of water intrusion or leaks, repairs by a qualified contractor and monitor for future water intrusion.

Minor staining on framing below front entry stairs

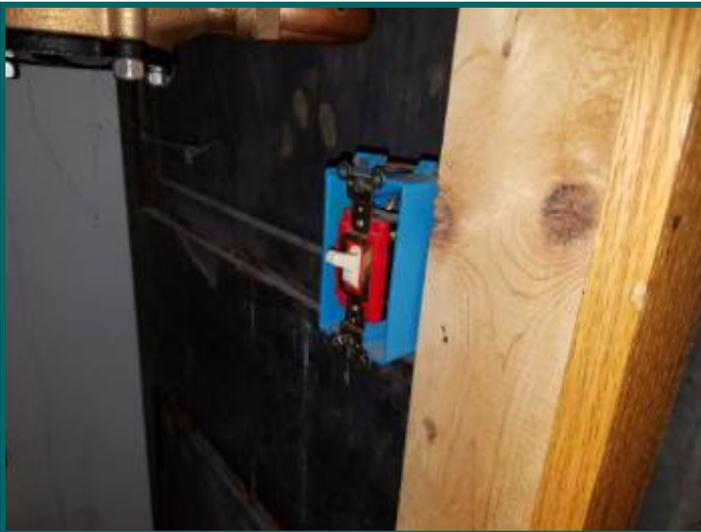
6.2. One or more outlet / switch cover plates missing. Recommend repairs for safety.

Plate cover missing above water heater

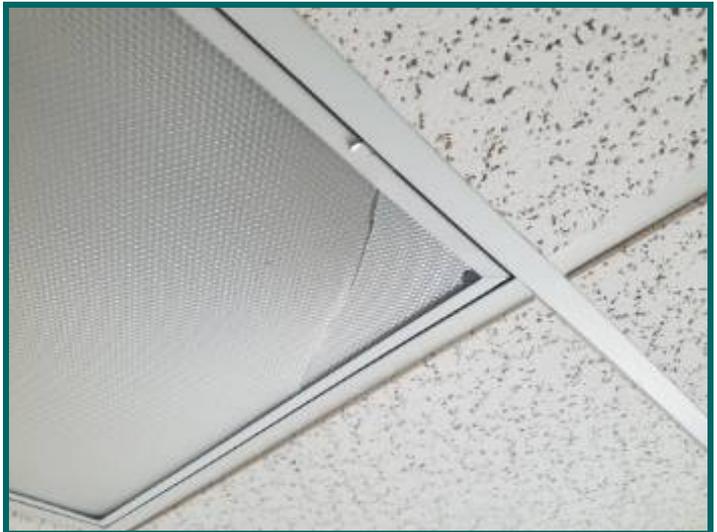
6.3. One or more ceiling light has a damaged lense / globe, recommend repair by a licensed electrician.

Damaged/cracked lense at first floor hall

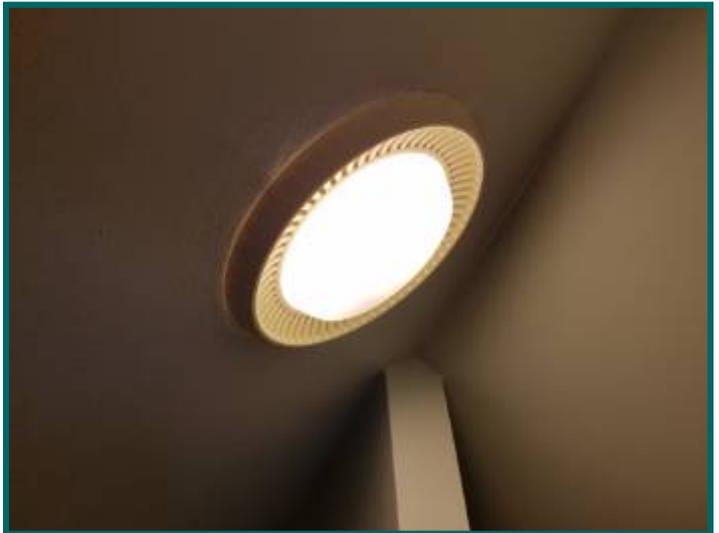
7.2. Exhaust fan does not operate properly at one or more bathroom, may require repair or replacement by a qualified contractor.

Bath fan not working

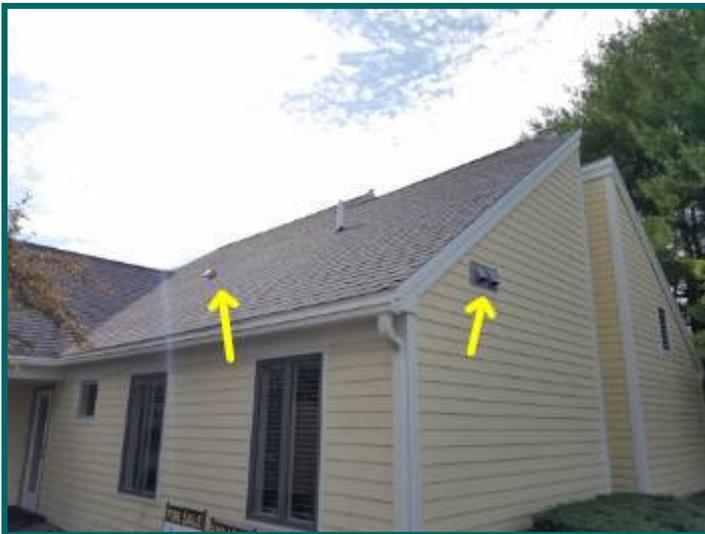
3 exterior terminations, bath fan termination could not be identified

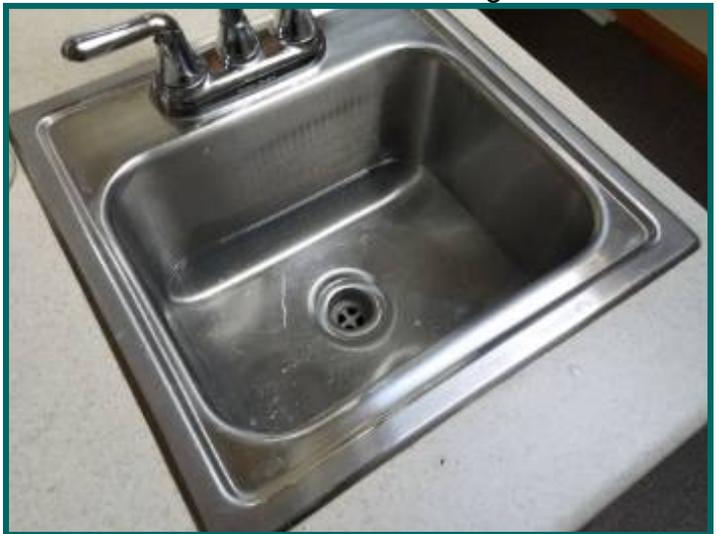
7.3. Sink drains slow at one or more location. Recommend clearing drain and servicing by a qualified plumber if needed.

Slow drain at sink, gargling and bubbling, may be venting related

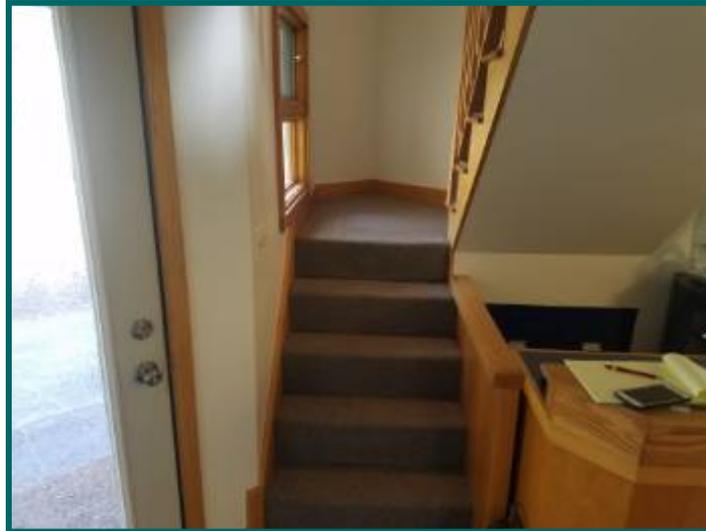
8.2. Stairs have one or more area of handrail missing. Recommend installing proper hand rail and balusters by a qualified contractor for safety.

Missing hand rail at first floor
