PROPERTY INSPECTION REPORT

Steve Mangekian License # 0054
Alpha Home & Commercial Building Inspections

Date of Inspection: 7/20/2020

The subject property is an office condominium approximately 1,150 sq ft, reported to be constructed in 1984.

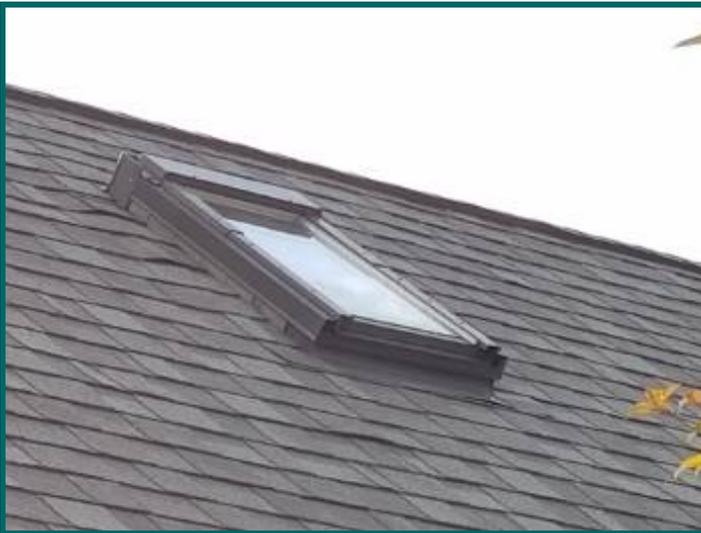
Front

1.2. One or more skylights are fogged, speckle or streaking stains on glass. This is an indication of a broken seal in double panes of glass Recommend assessment of skylights and repairs by a qualified contractor as needed.

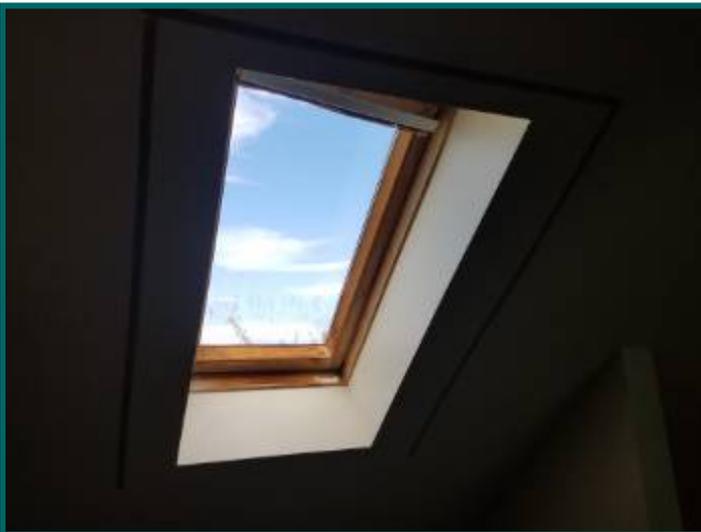
Front

1.3. Sky lights have damage to interior trim, recommend repair or replacement as needed by a qualified contractor.

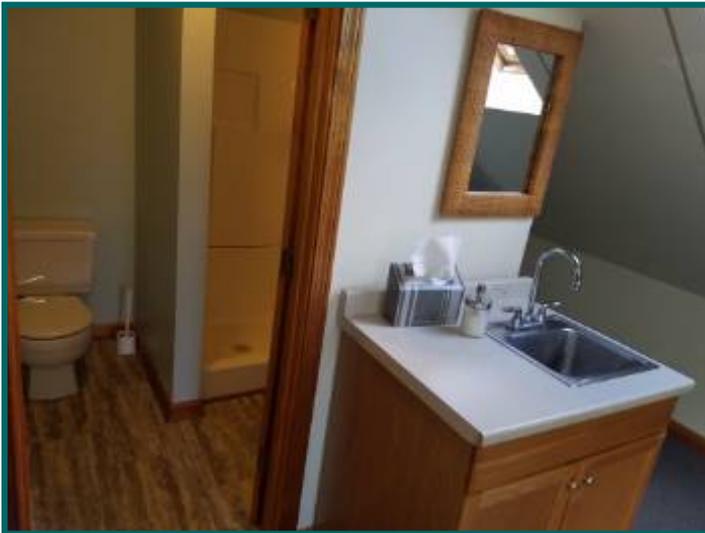
Second floor bathroom/sink

7.3. Sink drains slow at one or more location. Recommend clearing drain and servicing by a qualified plumber if needed.
